Surface protection

## PGE Arena Gdańsk

FAST SA scope of works: Surface protection

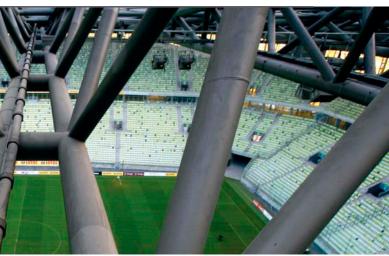
Side view of the structure of canopy girders. In the course of maintenance works, each element was subject to detailed quality controls.

Longitudinal view of canopy girders at the PGE Arena Gdańsk stadium. Anti-corrosive protection applied meeting the requirements of high cleaning and coating standards, in accordance with the following technology: washing - cleaning until class Sa 2,5 is obtained, 1st coat: paint - Interzinc 52, 60 micrones, 2nd coat: paint - Intergard 1251, 90 micrones, 3rd coat: paint - Intergard 475HS MIO, 90 micrones.

FAST SA performed works in the area of anti-corrosive protection of the stadium canopy structure elements: cleaning and applying a 3-layer coat of paints on a total area of ca. 15,000 sq.m.
