Project:
BLADT – an external platform, a component of a foundation structure for wind turbine towers

Project Owner/General Contractor:
Project Owner: Bladt Industries A/S
General Contractor:
Energomontaż-Północ Gdynia Sp. z o.o.

FAST SA scope of works:
Surface protection

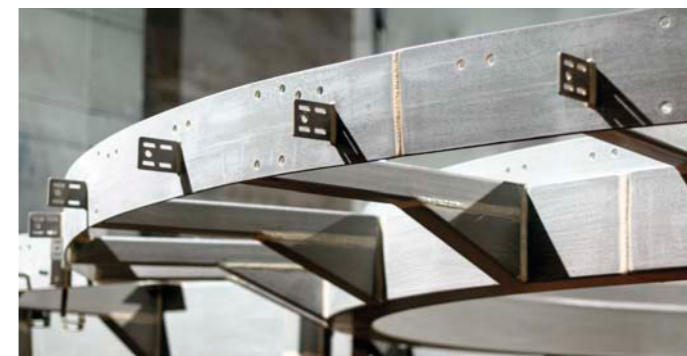
Before spray painting, all the joints, the necessary edges and elements, as well as confined areas were prepared manually (with the use of the stripe coating technique), so as to guarantee full paint penetration in such places.

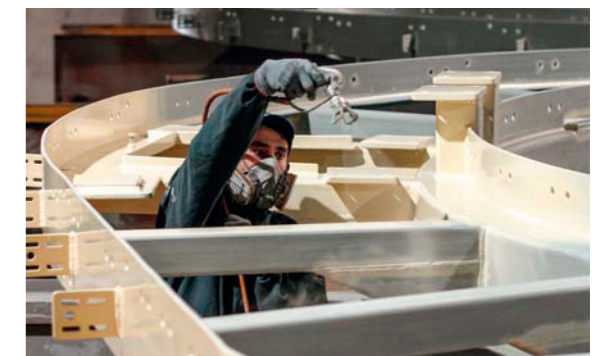
Airless spraying requires excellent skills from the painter in order to eliminate overspray or the so-called orange skin, with proper coat thickness maintained.
